Case Study Exercise

The Manor

- Size
 - 2 Stories, Garden Style, 84 Units
 - 75,602 square feet
- Age: 1984
 - Built in phases
- Structure
 - Concrete block walls
 - Concrete slab floors and wood framing roof
 - Brick veneer cladding
- Occupancy: Seniors, with rent and utility subsidies
- Utilities
 - Common areas are metered for electric and gas. Tenants are direct-metered for electric heat and domestic hot water.

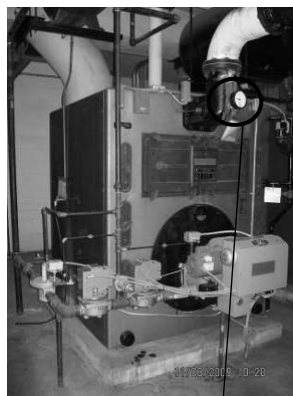
Boiler & Controls

- Gas-fired Weil-McClain hot water boiler for common areas supplies heat to ceiling units with 100% outdoor air and baseboard radiators
 - Broken pneumatic controls and no thermostats

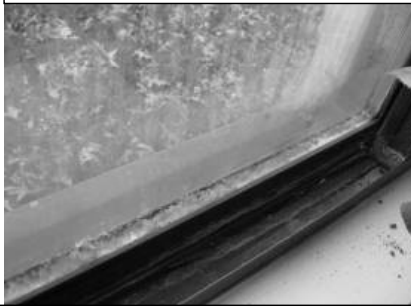
Apartment window with broken seal and unknown material settled in between panes.

Energy Star Window Replacements Replace compromised windows with new units with U-value <0.35 (approx 5)	\$5,000	\$82	25	-3,572	61	0.29	Owner
ERV Install energy recovery ventilation system to precondition the outdoor air delivered to hallway ceiling heating units. (If option 2 for ventilation)	\$6,000	\$100	15	-4,806	60	0.2	Owner
Remove inoperable mechanical equipment. Patch roof membrane.	\$26,000	N/A	N/A	N/A	N/A	N/A	Owner

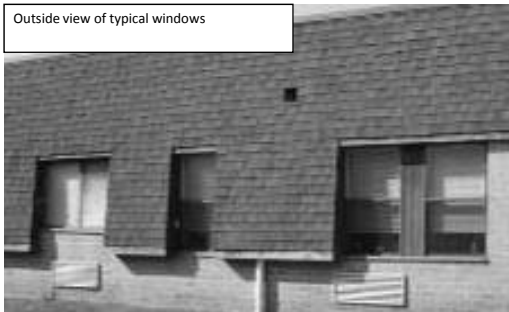
Outside view of typical windows

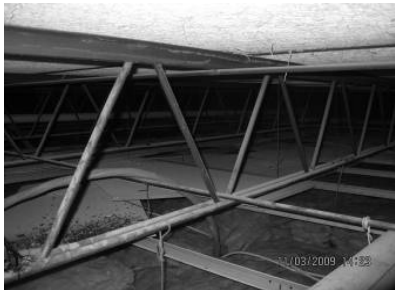
Existing building B drop ceiling in hallway.

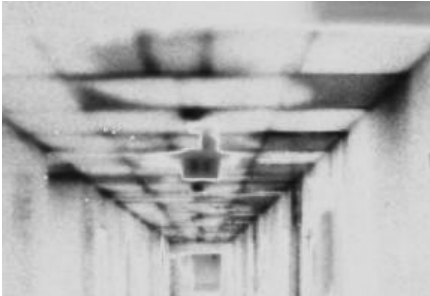
Ceiling access panel

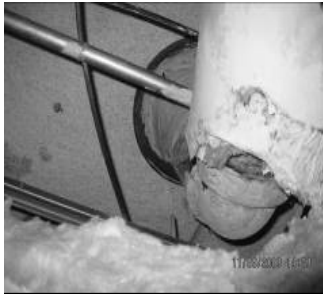
Photo taken from inside roof cavity of a roof drain. Super stated two of the drains leak within the building.

HEALTH & SAFETY MEASURES	EST. COST
Moisture Issues Verify perimeter drainage system operation, slope ground away from building & fix gutters. Repair connection between the drain on the roof and the roof membrane. Install vapor barrier over floor in crawlspace. Close off grille between stairwell & crawlspace. Note: moisture levels must be reduced before building air sealing work can begin.	\$44,389
Apartment Exhaust Venting: Option 1 Upgrade bathroom vents in Building B and C to exhaust to the outside using current controls.	\$10,000
Apartment Exhaust Venting: Option 2 Upgrade bathroom vents in Building B and C to continuously exhaust to the outside.	\$16,000
Cleaning and Sealing Clean grilles and ducts for laundry, bathroom and kitchen vents. Seal all exhaust ductwork that is accessible. Clean fan coils and filters in PTACs.	\$20,000
Other Install new soffit vent	\$60
Educate Tenants: Maintain DHW settings at 120F Temperature setting of 120F is low enough to reduce the risk of scalding but high enough to prevent bacteria called Legionella from growing in the DHW tank.	N/A

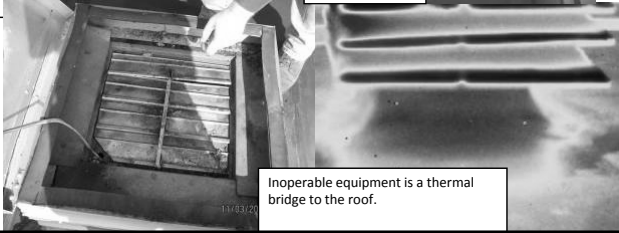
Inoperable equipment is a thermal bridge to the roof.
