National Center for Healthy Housing

Green Housing Series: Creating a Community Landmark

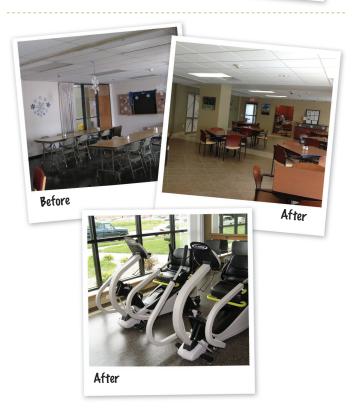
Orness Plaza Before and After

One of the most challenging steps in the design of Orness Plaza's renovation was determining how to stabilize its damaged foundation and add insulation to the concrete panel walls. After evaluating several different systems to replace or encapsulate the concrete panels, an Exterior Insulation and Finishing System (EIFS), which insulates the exterior walls and provides a finished surface resembling stucco, was chosen. The new system provides continuous insulation and achieves an R-value of 16.

There was also considerable air leakage between units and floors, which caused significant drafts and reduced not only the energy efficiency of the building, but also the comfort of its residents. After caulking the perimeter of the building from floor to floor and blanketing the building with EIFS, the building's insulation increased a whopping 500 percent.
