Case Study Exercise

The Manor

- Size
 - 2 Stories, Garden Style, 84 Units
 - 75,602 square feet
- Age: 1984
 - Built in phases
- Structure
 - Concrete block walls
 - Concrete slab floors and wood framing roof
 - Brick veneer cladding
- Occupancy: Seniors, with rent and utility subsidies
- Utilities
 - Common areas are metered for electric and gas. Tenants are direct-metered for electric heat and domestic hot water.

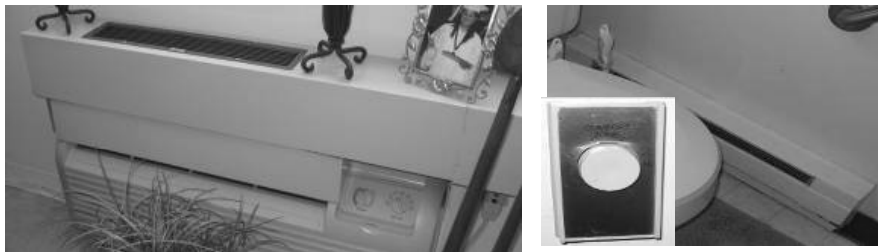
- Electric PTACs in the units for apartment heating & cooling plus electric baseboard in the bath

Airsealing	41	17,399	\$60,000	\$5,180	15	1,839	11.58	1.0	Both
Apartment PTAC Replacement	0	99,382	\$165,000	\$13,913	15	1,098	12.2	1.0	Tenant
Combined Package	-13	207,636	\$284,675	\$32,040		\$59,654	9	1.2

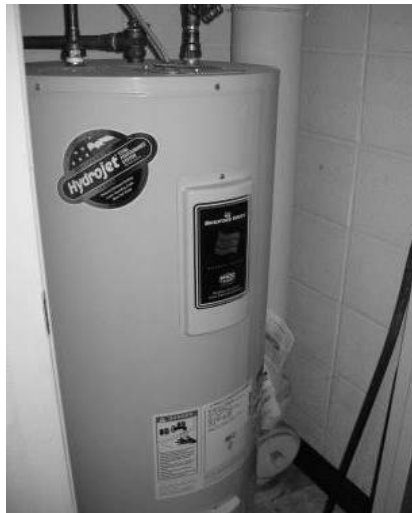
- Electric DHW makers in each unit

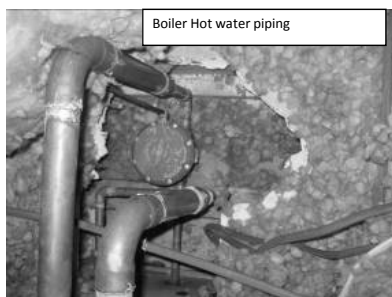
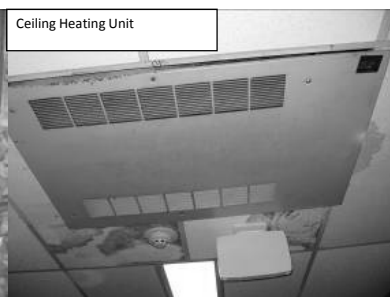
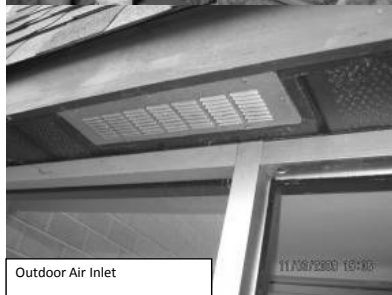
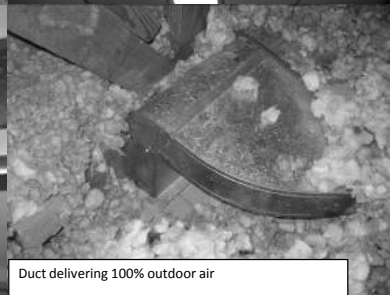
Common Area Heating

- Gas-fired Weil-McClain hot water boiler for common areas supplies heat to ceiling units with 100% outdoor air and baseboard radiators
 - Broken pneumatic controls and no thermostats

Energy Measures, Not Recommended (SIR <1.0)	Est. Cost	Est. Annual Savings	Measure Life	Life Cycle Savings (2009 \$)	Simple Payback (Years)	Savings-To-Investment Ratio	Savings Benefit
Common Area Lighting (Option 2) Remove T12 lamps. Install bi-level T8 lamps and electronic ballast with sensor (occupancy or photocell where skylights are present). Replace incandescent bulbs with screw in compact fluorescent bulbs.	\$68,000	\$5,244	15	-5,397	13	0.92	Owner
Skylights Replace two skylights, install new flashing	\$5,000	\$275	20	-909	18.2	0.82	Owner
Roof Insulation Additional cellulose insulation in building B and C	\$25,592	\$978	25	-8,562	26.2	0.67	Owner
Thermostatic Control Install thermostat on hallway baseboard	\$8,500	\$500	10	-4,235	17	0.5	Owner
Energy Star Refrigerators Install (64) Energy Star refrigerators	\$38,400	\$1,507	15	-20,410	25.5	0.47	Tenant
Upgrade Boiler Install two sealed combustion boilers (includes modulating burner, outdoor reset, time clock, repair controls)	\$65,000	\$1,646	20	-40,512	39.5	0.38	Owner

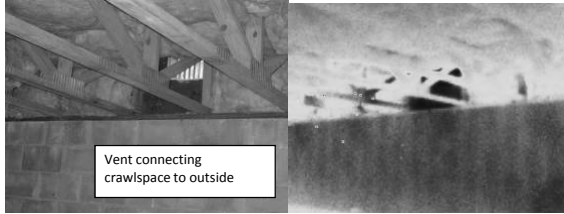
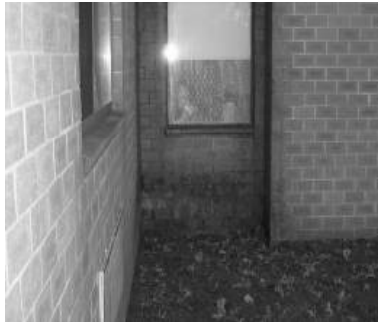
Apartment window with broken seal and unknown material settled in between panes.

Energy Star Window Replacements Replace compromised windows with new units with U-value <0.35 (approx 5)	\$5,000	\$82	25	-3,572	61	0.29	Owner
ERV Install energy recovery ventilation system to precondition the outdoor air delivered to hallway ceiling heating units. (If option 2 for ventilation)	\$6,000	\$100	15	-4,806	60	0.2	Owner
Remove inoperable mechanical equipment. Patch roof membrane.	\$26,000	N/A	N/A	N/A	N/A	N/A	Owner

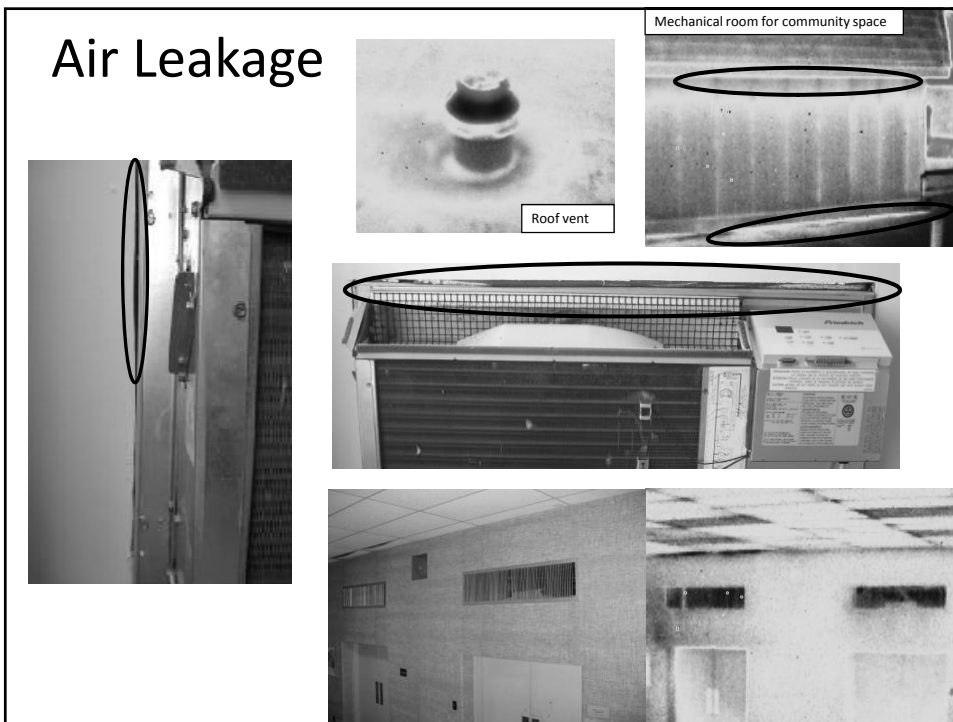
Air Leakage

Inoperable equipment is a thermal bridge to the roof.

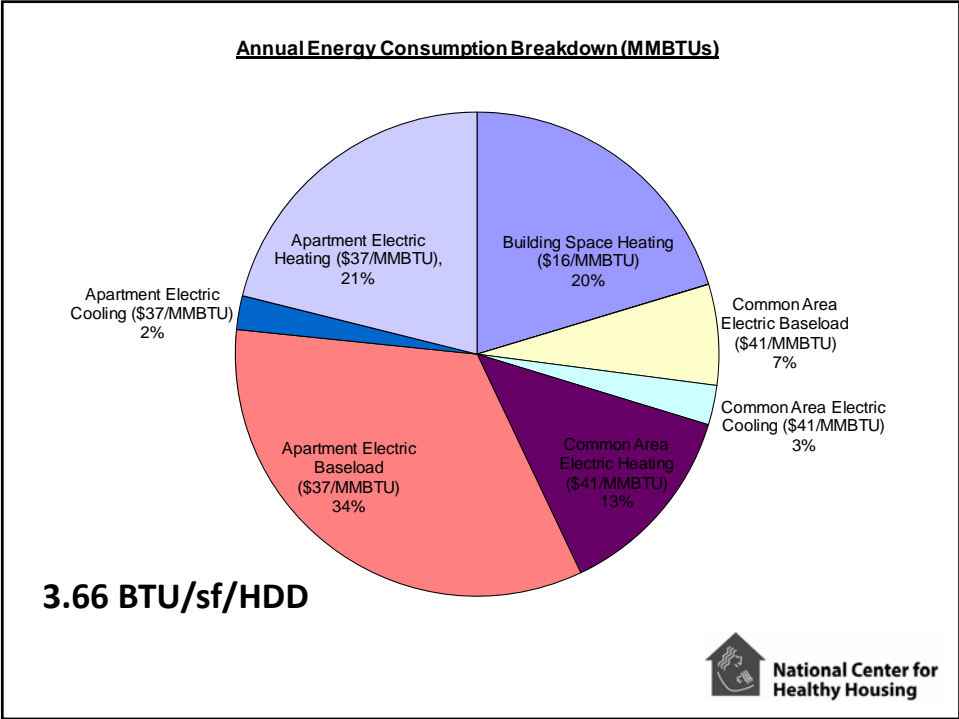
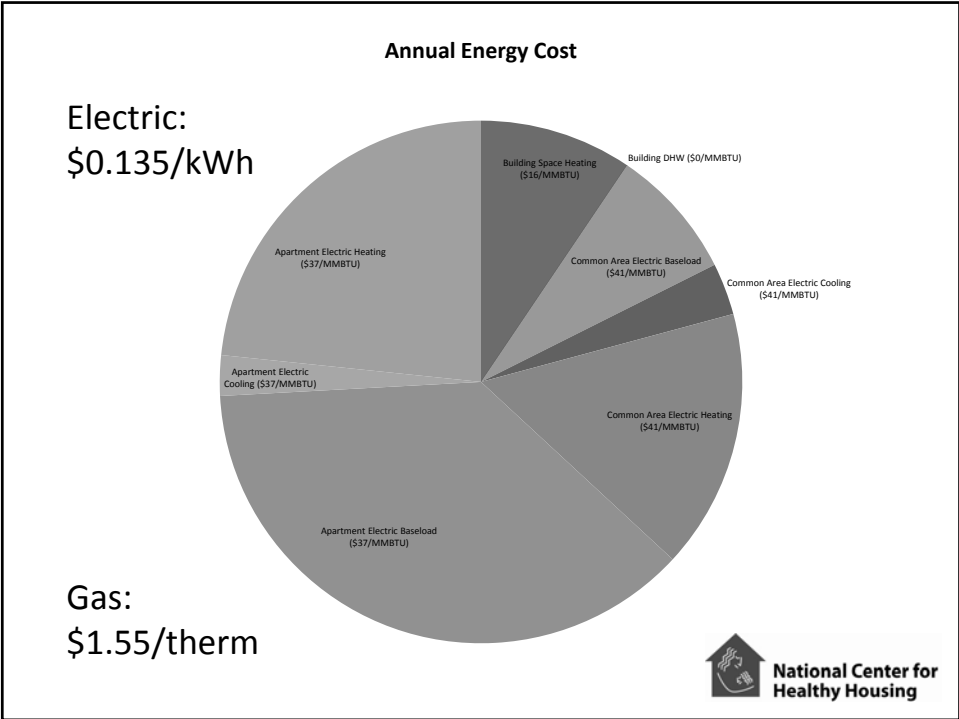
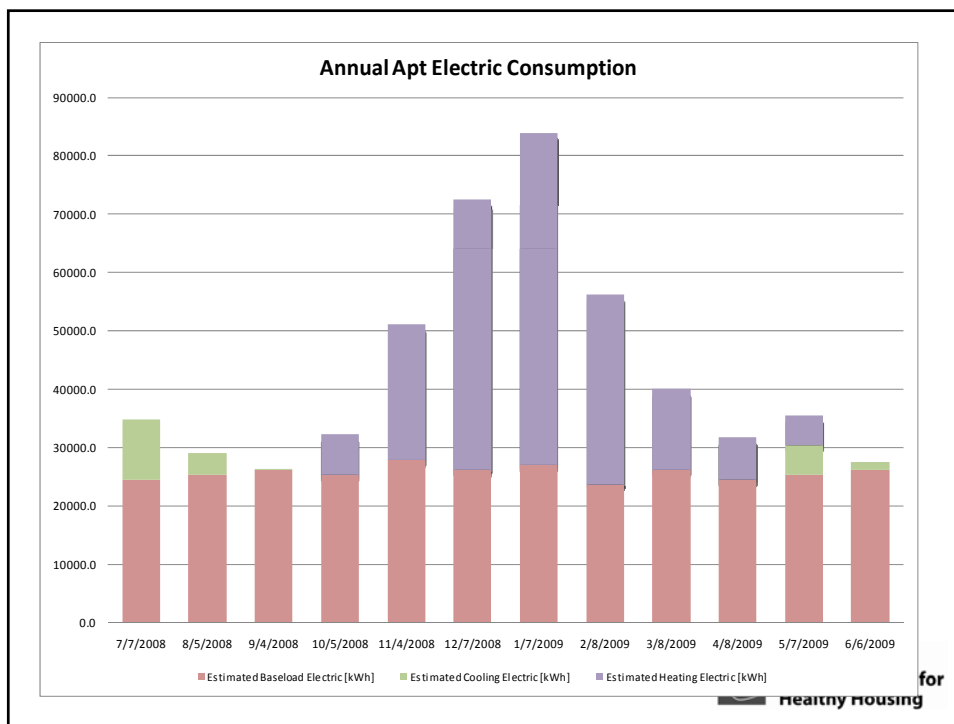
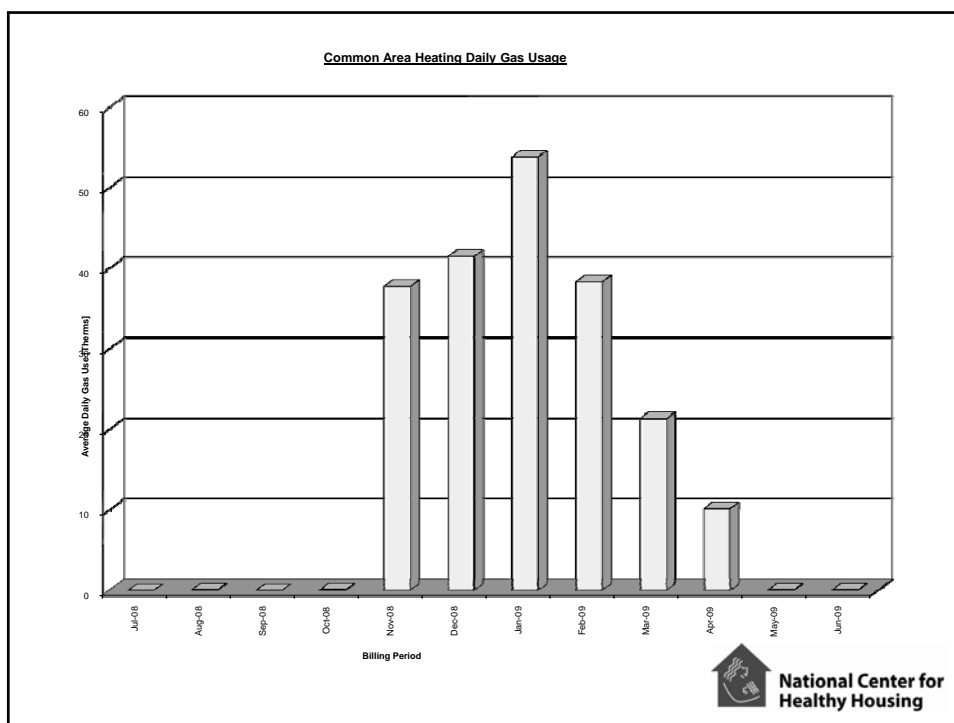
Lighting & Appliances

- All lights were T12 or incandescent
 - The building manager had taken out bulbs of every other fixture in the hallways
- Appliances were mostly original (1987)
